# Access Compliance Report Public Rights-of-Way (Curb Ramps)

Main Street: ETHELBEE\_WAY Cross Street: KEEGAN\_WAY Location: SW

ADA ID: RPAT210930085504 Ramp Type: Type 1 - Perpendicular Diagonal Initial Pass/Fail: Fail Overall Compliance: No Severity Score: 15

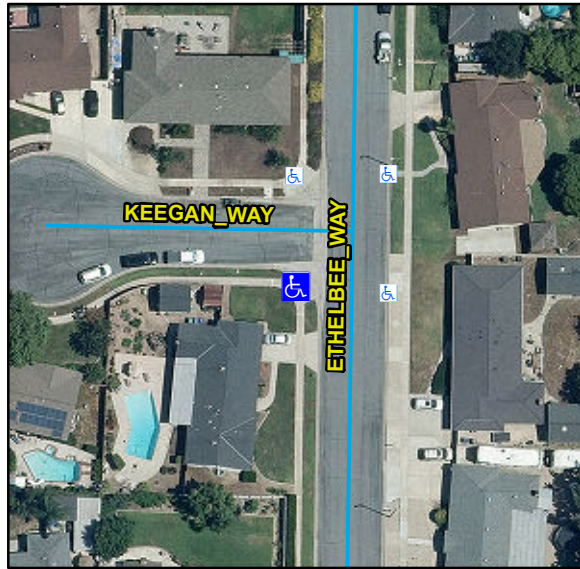
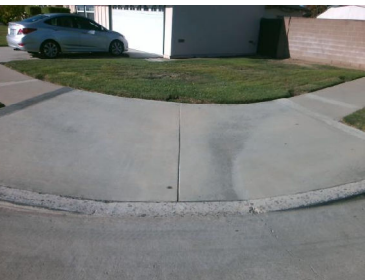
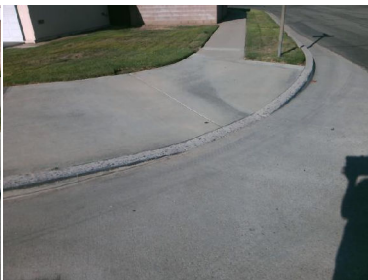
| Compliance | Description | Data | Compliance | Description | Data |
|---|---|---|---|---|---|
| No | Ramp Run Slope (%) | 8.9 | N/A | Flare Slope LT (%) | N/A |

**Remove & Replace Curb Ramp With Two New Directional Ramps or Equivalent.**

**R304.2.2, STD 1115**
