# Access Compliance Report Public Rights-of-Way (Curb Ramps)

Main Street: GROVEMONT\_ST Cross Street: ETHELBEE\_WAY Location: NW

ADA ID: RPAT210930085849 Ramp Type: Type 1 - Perpendicular Diagonal Initial Pass/Fail: Fail Overall Compliance: No Severity Score: 35

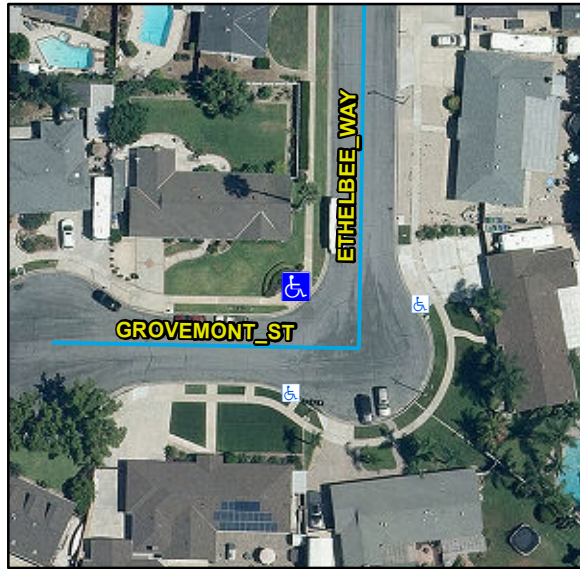
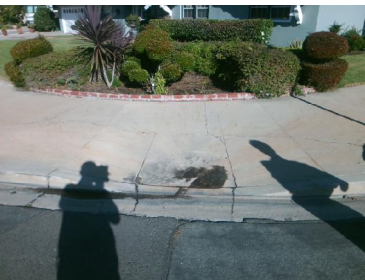
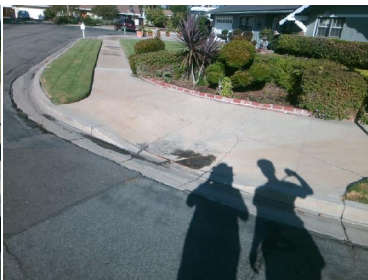
| Compliance | Description | Data | Compliance | Description | Data |
|---|---|---|---|---|---|
| No | Ramp Width (in) | 46 | | | N/A |
| No | Ramp Run Slope (%) | 10.4 | N/A | Flare Slope LT (%) | N/A |
| No | Overall Surface Condition: | Poor | Yes | Perp Joint Present | Yes |

**Remove & Replace Curb Ramp With Two New Directional Ramps or Equivalent.**

**R304.5.1, R304.2.2, R302.7, STD 1115**
