# Access Compliance Report Public Rights-of-Way (Curb Ramps)

Main Street: FAIRHAVEN\_AVE Cross Street: FAIRMONT\_WAY Location: SE

ADA ID: RPAT210930091252 Ramp Type: Type 1 - Perpendicular Diagonal Initial Pass/Fail: Fail Overall Compliance: No Severity Score: 19

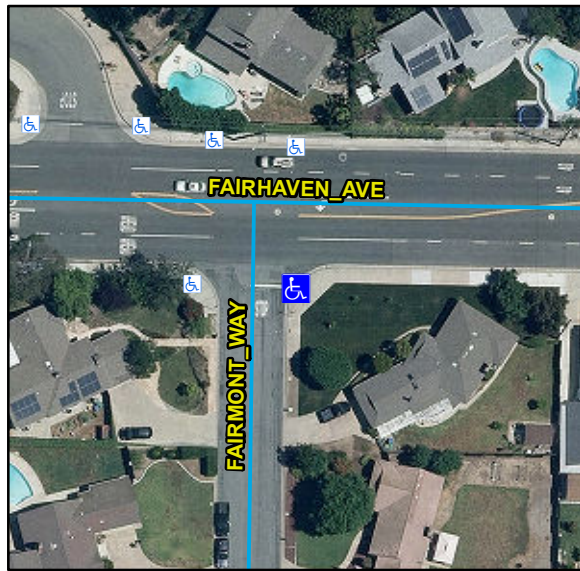
| Compliance | Description | Data | Compliance | Description | Data |
|---|---|---|---|---|---|
| No | Ramp Width (in) | 43 | | | N/A |
| No | Ramp Run Slope (%) | 9.4 | N/A | Flare Slope LT (%) | N/A |

Remove & Replace Curb Ramp With Two New Directional Ramps or Equivalent.

R304.5.1, R304.2.2, STD 1115
