# Access Compliance Report Public Rights-of-Way (Curb Ramps)

Main Street: ALLEGHENY\_DR Cross Street: LORETTA\_DR Location: NW

ADA ID: RPAT210930094442 Ramp Type: Type 1 - Perpendicular Diagonal Initial Pass/Fail: Pass Overall Compliance: No Severity Score: 26

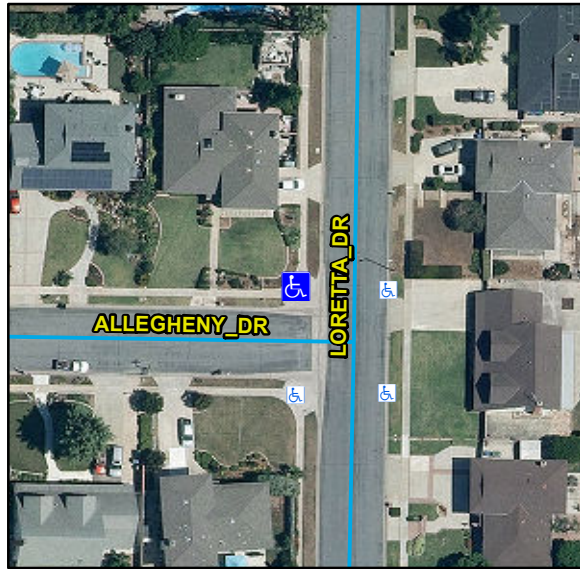
| Compliance | Description | Data | Compliance | Description | Data |
|---|---|---|---|---|---|
| No | Landing Width (in) | N/A | N/A | Flare Slope RT (%) | 4.9 |
| No | Landing Run Slope (%) | N/A | N/A | Flare Traversable RT | No |
| No | Landing Cross Slope (%) | N/A | No | DWS Provided | No |
| Yes | Gutter Ponding | No | No | Curb Slope | 7.9 |
| No | Gutter Run Slope (%) | 5.1 | | Road Cross Slope (%) | 5.3 |

Remove & Replace Curb Ramp With Two New Directional Ramps or Equivalent. Remove & Replace Gutter.
