# Access Compliance Report Public Rights-of-Way (Curb Ramps)

Main Street: LORETTA\_DR Cross Street: ALLEGHENY\_DR Location: SW

ADA ID: RPAT210930094852 Ramp Type: Type 1 - Perpendicular Diagonal Initial Pass/Fail: Fail Overall Compliance: No Severity Score: 2

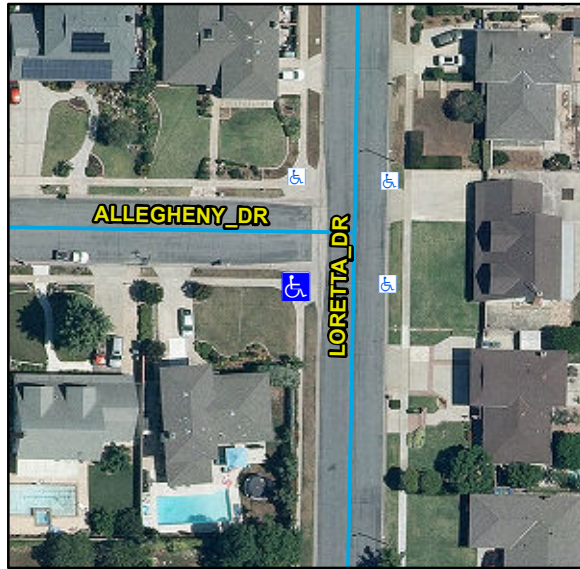
| Compliance | Description | Data | Compliance | Description | Data |
|---|---|---|---|---|---|
| No | Ramp Cross Slope (%) | 3.8 | N/A | Flare Traversable LT | N/A |

Remove & Replace Curb Ramp With Two New Directional Ramps or Equivalent.

R304.2.2, R304.5.3, STD 1115
