# Access Compliance Report Public Rights-of-Way (Curb Ramps)

Main Street: MEREDITH\_DR Cross Street: LORETTA\_DR Location: NW

ADA ID: RPAT210930095301 Ramp Type: Type 1 - Perpendicular Diagonal Initial Pass/Fail: Pass Overall Compliance: No Severity Score: 26

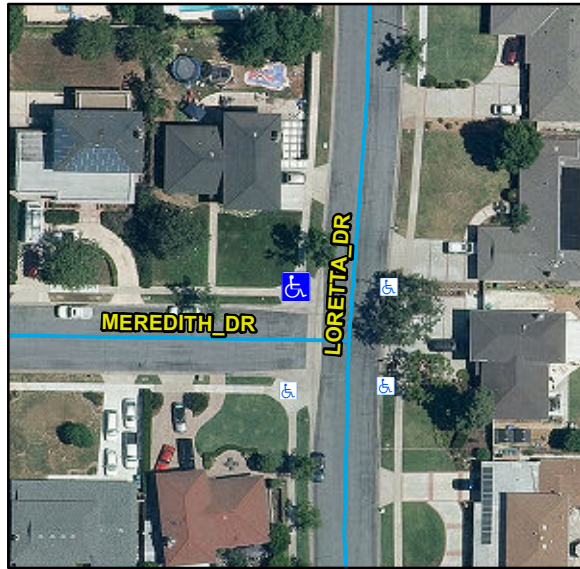
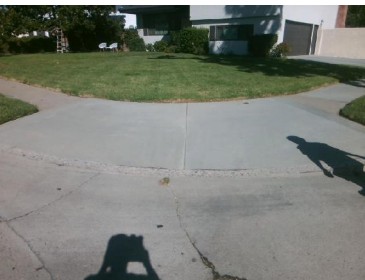
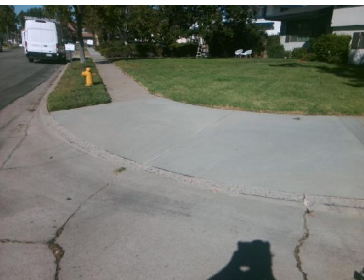
| Compliance | Description | Data | Compliance | Description | Data |
|---|---|---|---|---|---|
| No | Landing Width (in) | N/A | N/A | Flare Slope RT (%) | 7.4 |
| No | Landing Run Slope (%) | N/A | N/A | Flare Traversable RT | No |
| No | Landing Cross Slope (%) | N/A | No | DWS Provided | No |
| Yes | Gutter Ponding | No | No | Curb Slope | 9.6 |
| No | Gutter Run Slope (%) | 5.5 | | Road Cross Slope (%) | 4.3 |

Remove & Replace Curb Ramp With Two New Directional Ramps or Equivalent. Remove & Replace Gutter.
