# Access Compliance Report Public Rights-of-Way (Curb Ramps)

Main Street: LORETTA\_DR Cross Street: MEREDITH\_DR Location: SW

ADA ID: RPAT210930095644 Ramp Type: Type 1 - Perpendicular Diagonal Initial Pass/Fail: Fail Overall Compliance: No Severity Score: 0

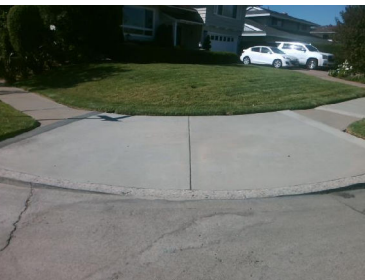
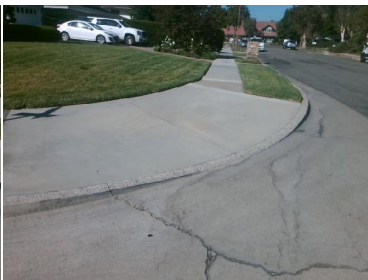
| Compliance | Description | Data | Compliance | Description | Data |
|---|---|---|---|---|---|
| Yes | Overall Surface Condition: Acceptable | | Yes | Perp Joint Present | Yes |

Remove & Replace Curb Ramp With Two New Directional Ramps or Equivalent.
