# Access Compliance Report Public Rights-of-Way (Curb Ramps)

| Main Street: EDDY_DR | | Cross Street: LORETTA_DR | | Location: | NW |
| ADA ID: RPAT210930100055 | Ramp Type:Type 1 - Perpendicular Diagonal Initial Pass/Fail: Fail | | Overall Compliance: No | Severity Score: | 2 |

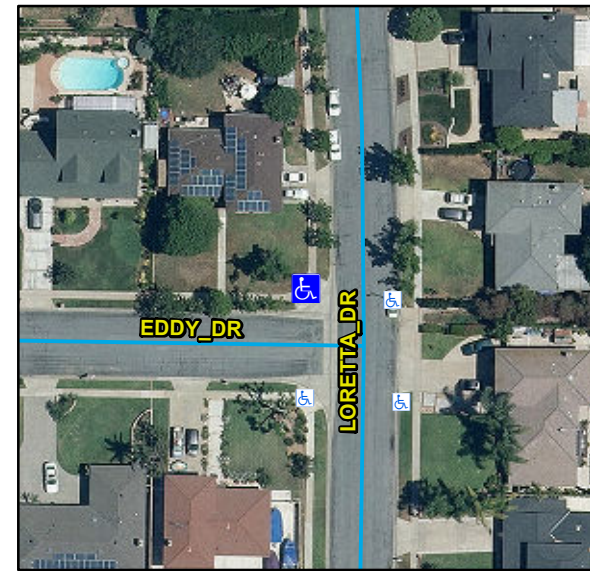
| Compliance | Description | Data | Compliance | Description | Data |
|---|---|---|---|---|---|
| No | Ramp Cross Slope (%) | 3.1 | N/A | Flare Traversable LT | N/A |

**Remove & Replace Curb Ramp With Two New Directional Ramps or Equivalent.**

**R304.2.2, R304.5.3, STD 1115**
