# Access Compliance Report Public Rights-of-Way (Curb Ramps)

Main Street: LORETTA\_DR Cross Street: EDDY\_DR Location: SW

ADA ID: RPAT210930100502 Ramp Type: Type 1 - Perpendicular Diagonal Initial Pass/Fail: Fail Overall Compliance: No Severity Score: 0

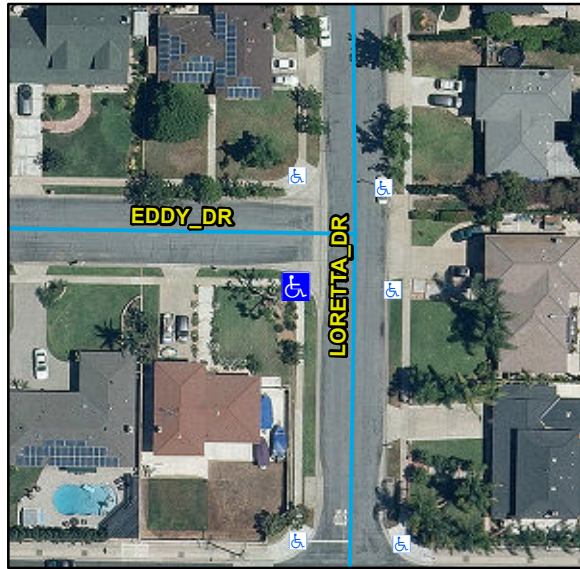
## Field Measurements/Component Compliance

Possible Solutions:

**Remove & Replace Curb Ramp With Two New Directional Ramps or Equivalent.**

**STD 1115**
