# Access Compliance Report Public Rights-of-Way (Curb Ramps)

Main Street: RAINIER\_DR Cross Street: LORETTA\_DR Location: SE

ADA ID: RPAT210930102042 Ramp Type: Type 1 - Perpendicular Diagonal Initial Pass/Fail: Pass Overall Compliance: No Severity Score: 25

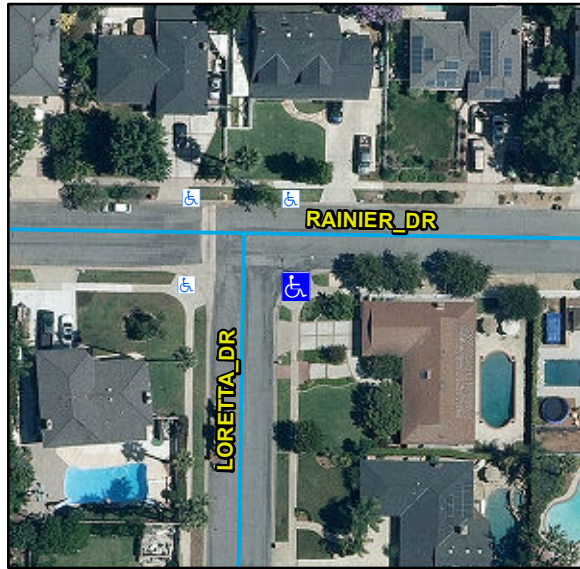
| Compliance | Description | Data | Compliance | Description | Data |
|---|---|---|---|---|---|
| N/A | Ramp Length (in) | 132 | N/A | Flare Type LT | |
| Yes | Ramp Width (in) | 59 | | | Sloped |
| Yes | Ramp Run Slope (%) | 6.8 | N/A | Flare Slope LT (%) | 9 |
| Yes | Ramp Cross Slope (%) | 2 | N/A | Flare Traversable LT | No |
| No | Landing Width (in) | N/A | N/A | Flare Slope RT (%) | 4.1 |
| No | Landing Run Slope (%) | N/A | N/A | Flare Traversable RT | No |
| No | Landing Cross Slope (%) | N/A | No | DWS Provided | No |
| No | Gutter Run Slope (%) | 5.2 | | Road Cross Slope (%) | 5.7 |

Remove & Replace Curb Ramp With Two New Directional Ramps or Equivalent. Remove & Replace Gutter.

R204.3, R304.2.1, R304.2.2-Perp, R304.3.2-Para, R304.5.3, R305, R304.5.4, STD 1115

Total Cost: \$ 6412
