# Access Compliance Report Public Rights-of-Way (Curb Ramps)

Main Street: LORETTA\_DR Cross Street: RAINIER\_DR Location: SW

ADA ID: RPAT210930102356 Ramp Type: Type 1 - Perpendicular Diagonal Initial Pass/Fail: Pass Overall Compliance: No Severity Score: 20

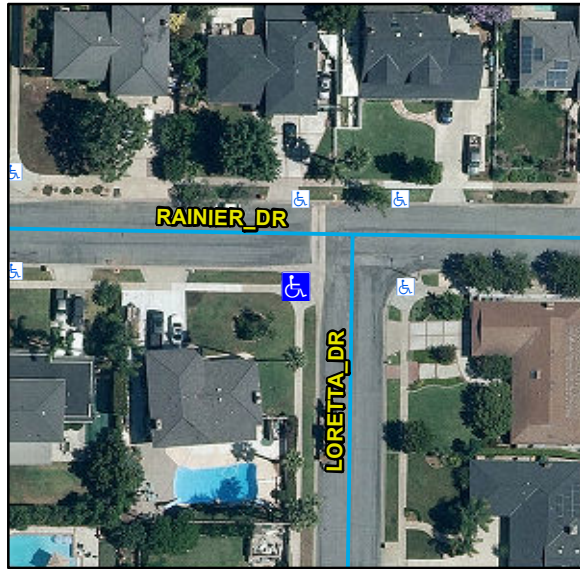
| Compliance | Description | Data | Compliance | Description | Data |
|---|---|---|---|---|---|
| Yes | Ramp Run Slope (%) | 6.6 | N/A | Flare Slope LT (%) | 3.4 |
| No | Landing Width (in) | N/A | N/A | Flare Slope RT (%) | 7 |
| No | Landing Run Slope (%) | N/A | N/A | Flare Traversable RT | No |
| No | Landing Cross Slope (%) | N/A | No | DWS Provided | No |

Remove & Replace Curb Ramp With Two New Directional Ramps or Equivalent.
