# Access Compliance Report Public Rights-of-Way (Curb Ramps)

Main Street: RAINIER\_DR Cross Street: WHEELER\_PL Location: SE

ADA ID: RPAT210930103237 Ramp Type: Type 1 - Perpendicular Diagonal Initial Pass/Fail: Pass Overall Compliance: No Severity Score: 26

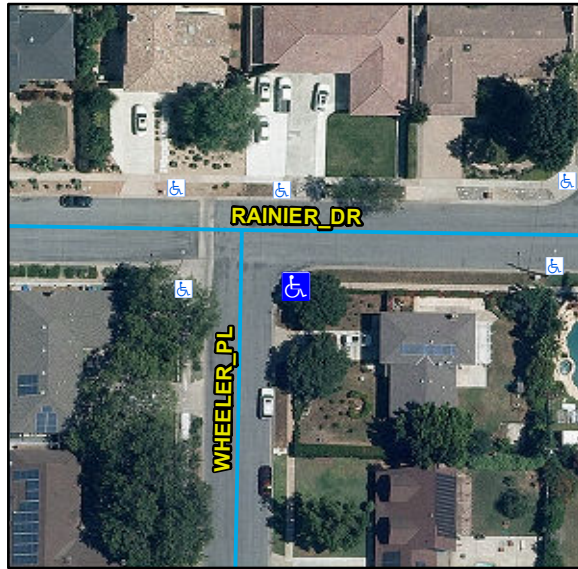
R304.2.2, R204.3, R304.2.1, R304.2.2-Perp, R304.3.2-Para, R304.5.3, R305, R304.5.4, STD 1115

Remove & Replace Curb Ramp With Two New Directional Ramps or Equivalent. Remove & Replace Gutter.
