# Access Compliance Report Public Rights-of-Way (Curb Ramps)

Main Street: RAINIER\_DR Cross Street: MALENA\_DR Location: NW

ADA ID: RPAT210930120355 Ramp Type: Type 1 - Perpendicular Diagonal Initial Pass/Fail: Fail Overall Compliance: No Severity Score: 4

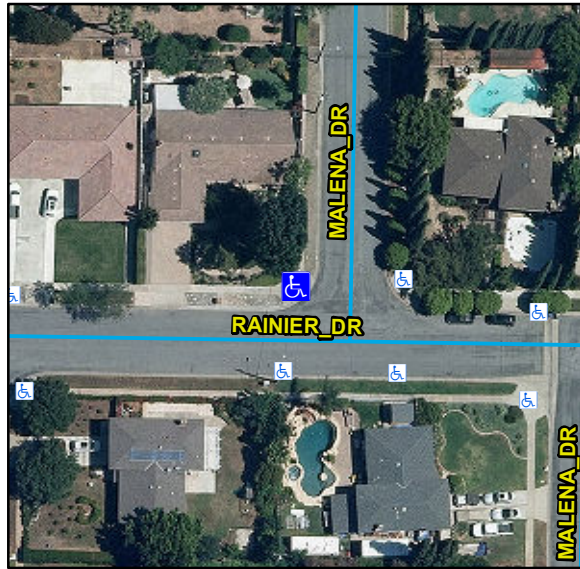
| Compliance | Description | Data | Compliance | Description | Data |
|---|---|---|---|---|---|
| No | Ramp Width (in) | 47 | | | N/A |

**Remove & Replace Curb Ramp With Two New Directional Ramps or Equivalent.**

**R304.5.1, STD 1115**
