# Access Compliance Report Public Rights-of-Way (Curb Ramps)

Main Street: MALENA\_DR Cross Street: RAINIER\_DR Location: SW

ADA ID: RPAT210930121213 Ramp Type: Type 1 - Perpendicular Diagonal Initial Pass/Fail: Pass Overall Compliance: No Severity Score: 20

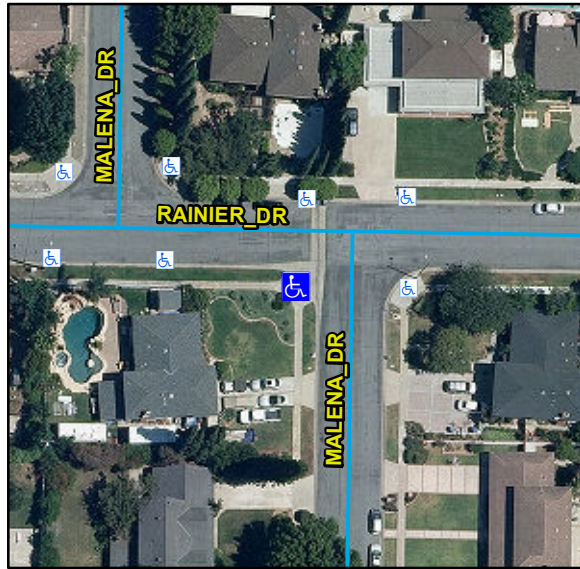
| Compliance | Description | Data | Compliance | Description | Data |
|---|---|---|---|---|---|
| No | Landing Width (in) | N/A | N/A | Flare Slope RT (%) | 7.1 |
| No | Landing Run Slope (%) | N/A | N/A | Flare Traversable RT | No |
| No | Landing Cross Slope (%) | N/A | No | DWS Provided | No |
| Yes | Gutter Ponding | No | No | Curb Slope | 7.6 |
| No | Gutter Cross Slope (%) | 3.1 | | | |

Remove & Replace Curb Ramp With Two New Directional Ramps or Equivalent. Remove & Replace Gutter.
