# Access Compliance Report Public Rights-of-Way (Curb Ramps)

Main Street: RAINIER\_DR Cross Street: MALENA\_DR Location: SE

ADA ID: RPAT210930121619 Ramp Type: Type 1 - Perpendicular Diagonal Initial Pass/Fail: Fail Overall Compliance: No Severity Score: 2

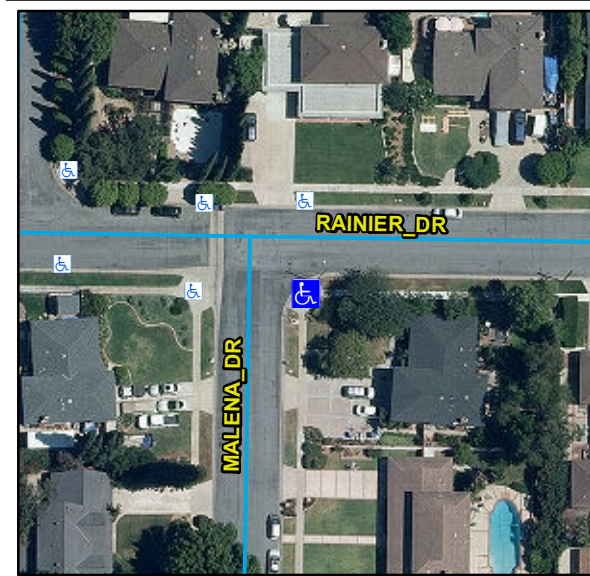
| Compliance | Description | Data | Compliance | Description | Data |
|---|---|---|---|---|---|
| No | Ramp Cross Slope (%) | 3.6 | N/A | Flare Traversable LT | N/A |

Possible Solutions:  
**Remove & Replace Curb Ramp With Two New Directional Ramps or Equivalent.**

OC Std/PROW:  
**R304.5.3, STD 1115**

Total Cost: \$ 6160
