# Access Compliance Report Public Rights-of-Way (Curb Ramps)

Main Street: MALENA\_DR Cross Street: ALLEGHENY\_DR Location: NE

ADA ID: RPAT210930122900 Ramp Type: Type 1 - Perpendicular Diagonal Initial Pass/Fail: Pass Overall Compliance: No Severity Score: 22

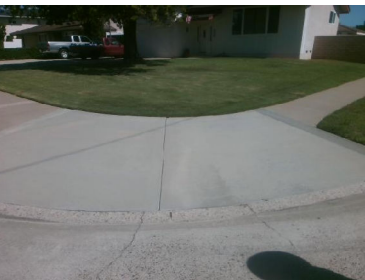
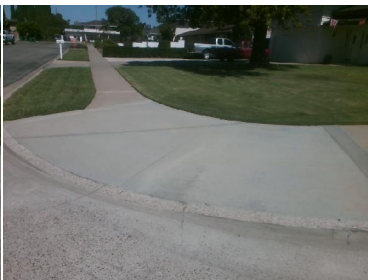
| Compliance | Description | Data | Compliance | Description | Data |
|---|---|---|---|---|---|
| No | Landing Cross Slope (%) | N/A | No | DWS Provided | No |
| Yes | Gutter Ponding | No | No | Curb Slope | 9.4 |

Remove & Replace Curb Ramp With Two New Directional Ramps or Equivalent.
