# Access Compliance Report Public Rights-of-Way (Curb Ramps)

Main Street: KOOTENAY\_DR Cross Street: LASSEN\_DR Location: SW

ADA ID: RPAT211001094543 Ramp Type: Type 1 - Perpendicular Diagonal Initial Pass/Fail: Pass Overall Compliance: No Severity Score: 25

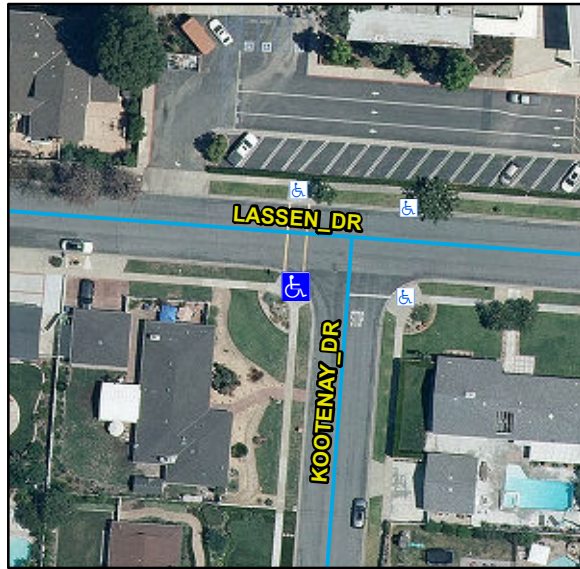
N/A

**Remove & Replace Curb Ramp With Two New Directional Ramps or Equivalent. Restripe Crosswalk. Remove & Replace Gutter.**

**R304.2.2, R204.3, R304.2.1, R304.2.2-Perp, R304.3.2-Para, R304.5.3, R305, R207.1, R304.5.4, STD 1115**
