# Access Compliance Report Public Rights-of-Way (Curb Ramps)

| Main Street: LASSEN_DR | | Cross Street: KOOTENAY_DR | | Location: | NW |
| ADA ID: RPAT211001094956 | Ramp Type:Type 1 - Perpendicular | Initial Pass/Fail: Fail | Overall Compliance: No | Severity Score: | 5 |

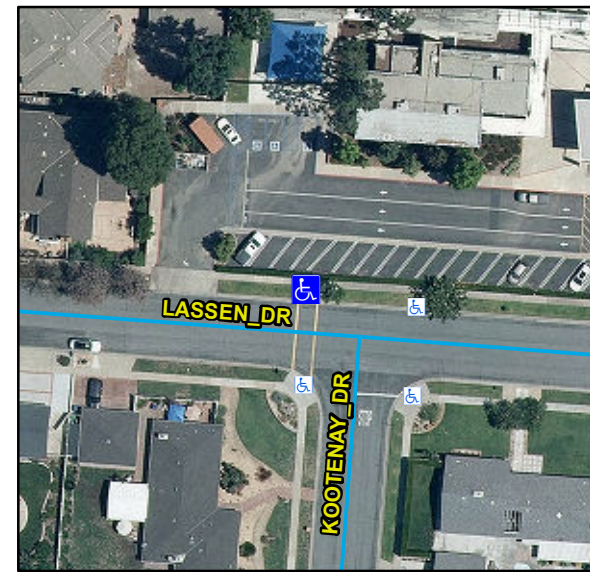
R304.2.2, R304.5.1, STD 1115

| Compliance | Description | Data | Compliance | Description | Data |
|---|---|---|---|---|---|
| No | Ramp Width (in) | 44 | | | N/A |

Remove & Replace Entire Ramp.
