# Access Compliance Report Public Rights-of-Way (Curb Ramps)

Main Street: LASSEN\_DR Cross Street: KOOTENAY\_DR Location: SE

ADA ID: RPAT211001095251 Ramp Type: Type 1 - Perpendicular Diagonal Initial Pass/Fail: Fail Overall Compliance: No Severity Score: 2

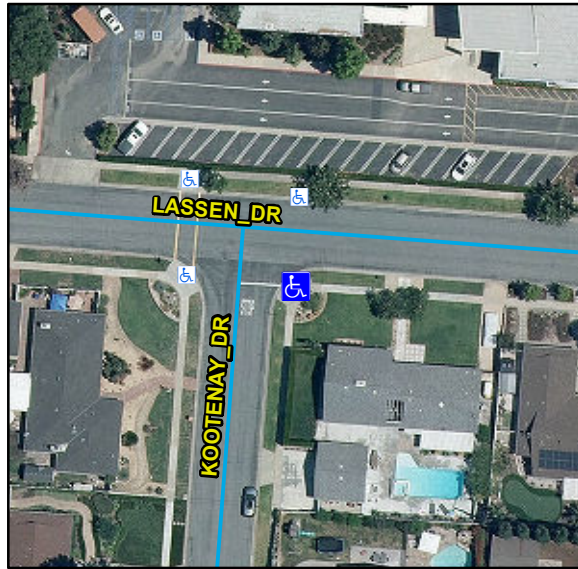
| Compliance | Description | Data | Compliance | Description | Data |
|---|---|---|---|---|---|
| No | Ramp Cross Slope (%) | 2.8 | N/A | Flare Traversable LT | N/A |

Remove & Replace Curb Ramp With Two New Directional Ramps or Equivalent.

R304.5.3, STD 1115

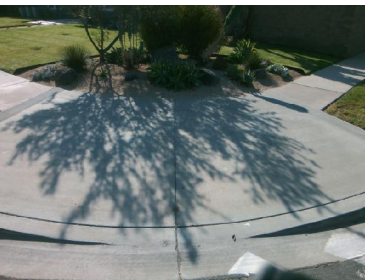
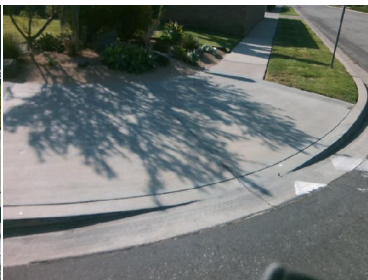
| Compliance | Description | Data | Compliance | Description | Data |
|---|---|---|---|---|---|
| Yes | Overall Surface Condition: Acceptable | | Yes | Perp Joint Present | Yes |
