# Access Compliance Report Public Rights-of-Way (Curb Ramps)

Main Street: WHITNEY\_DR Cross Street: KOOTENAY\_DR Location: SE

ADA ID: RPAT211001100238 Ramp Type: Type 6 - Directional 1 Initial Pass/Fail: Fail Overall Compliance: No Severity Score: 5

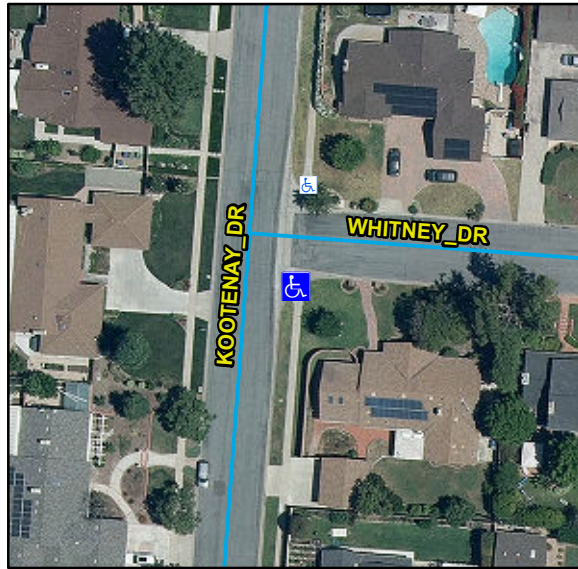
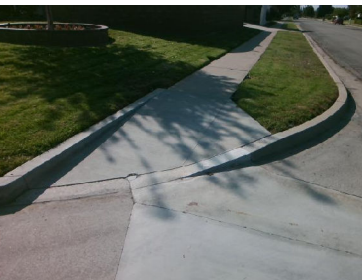
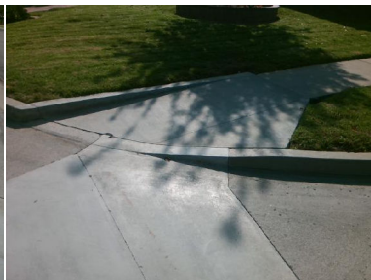
R304.5.1, R304.5.3, STD 1115

| Compliance | Description | Data | Compliance | Description | Data |
|---|---|---|---|---|---|
| No | Ramp Width (in) | 45 | | | N/A |
| No | Ramp Cross Slope (%) | 4.6 | N/A | Flare Traversable LT | N/A |

Remove & Replace Entire Ramp.
