# Access Compliance Report Public Rights-of-Way (Curb Ramps)

Main Street: RAINIER\_DR Cross Street: KOOTENAY\_DR Location: NE

ADA ID: RPAT211001100557 Ramp Type: Type 6 - Directional 1 Initial Pass/Fail: Fail Overall Compliance: No Severity Score: 2

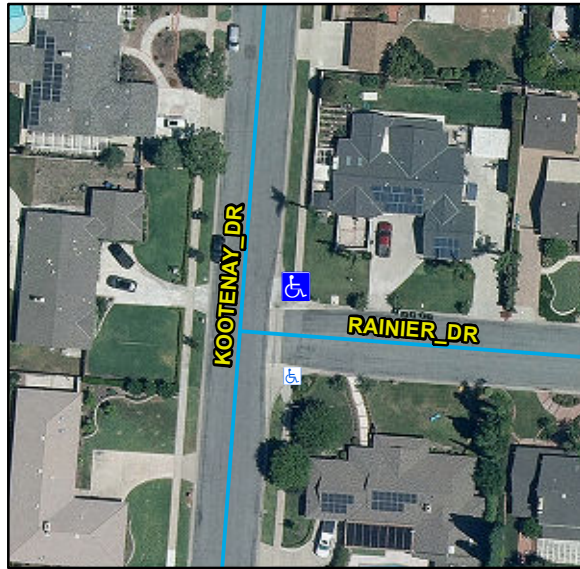
| Compliance | Description | Data | Compliance | Description | Data |
|---|---|---|---|---|---|
| No | Ramp Cross Slope (%) | 3.2 | N/A | Flare Traversable LT | N/A |

Possible Solutions:

Remove & Replace Entire Ramp.

R304.5.3, STD 1115
