# Access Compliance Report Public Rights-of-Way (Curb Ramps)

Main Street: KOOTENAY\_DR Cross Street: RAINIER\_DR Location: SE

ADA ID: RPAT211001100838 Ramp Type: Type 6 - Directional 1 Initial Pass/Fail: Fail Overall Compliance: No Severity Score: 2

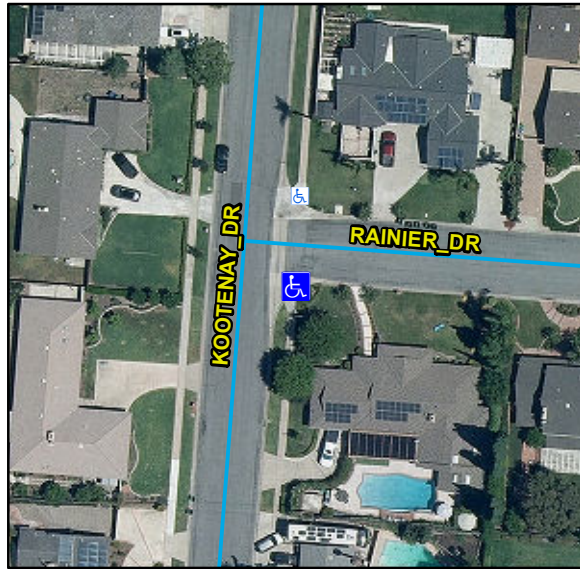
| Compliance | Description | Data | Compliance | Description | Data |
|---|---|---|---|---|---|
| No | Ramp Cross Slope (%) | 3 | N/A | Flare Traversable LT | N/A |

Remove & Replace Entire Ramp.

R304.5.3, STD 1115
