# Access Compliance Report Public Rights-of-Way (Curb Ramps)

Main Street: KOOTENAY\_DR Cross Street: CRANBROOK\_DR Location: NE

ADA ID: RPAT211001101411 Ramp Type: Type 1 - Perpendicular Diagonal Initial Pass/Fail: Pass Overall Compliance: No Severity Score: 20

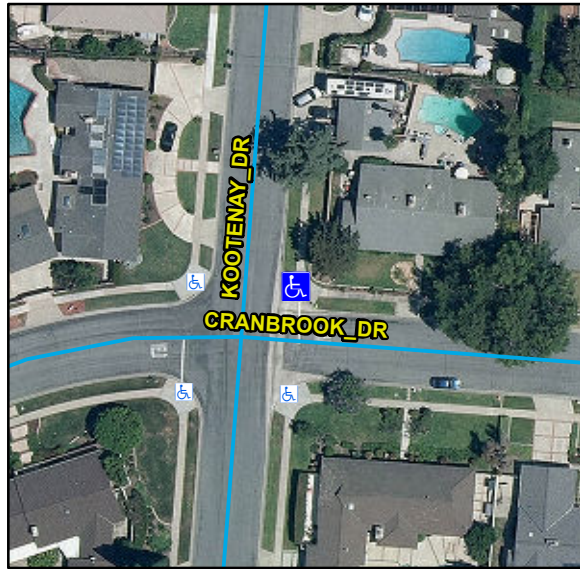
| Compliance | Description | Data | Compliance | Description | Data |
|---|---|---|---|---|---|
| No | Landing Width (in) | N/A | N/A | Flare Slope RT (%) | 4.9 |
| No | Landing Run Slope (%) | N/A | N/A | Flare Traversable RT | No |
| No | Landing Cross Slope (%) | N/A | No | DWS Provided | No |
| Yes | Gutter Ponding | No | No | Curb Slope | 9.4 |

Remove & Replace Curb Ramp With Two New Directional Ramps or Equivalent.
