# Access Compliance Report Public Rights-of-Way (Curb Ramps)

Main Street: CRANBROOK\_DR Cross Street: KOOTENAY\_DR Location: SE

ADA ID: RPAT211001101923 Ramp Type: Type 1 - Perpendicular Diagonal Initial Pass/Fail: Pass Overall Compliance: No Severity Score: 20

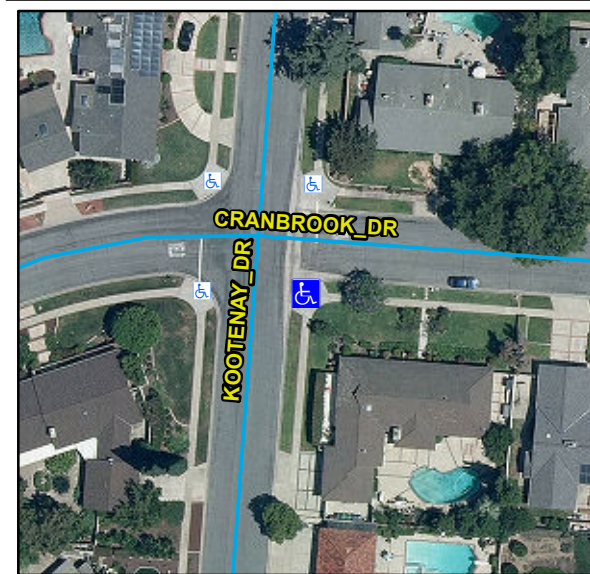
Surveyor Notes:  
**N/A**

Possible Solutions:  
**Remove & Replace Curb Ramp With Two New Directional Ramps or Equivalent.**

OC Std/PROW:  
**R204.3, R304.2.1, R304.2.2-Perp, R304.3.2-Para, R304.5.3, R305, STD 1115**
