# Access Compliance Report Public Rights-of-Way (Curb Ramps)

| Main Street: ALLEGHENY_DR | | Cross Street: KOOTENAY_DR | | Location: | NE |
| ADA ID: RPAT211001102338 | Ramp Type: Type 6 - Directional 1 | Initial Pass/Fail: Fail | Overall Compliance: No | Severity Score: | 20 |

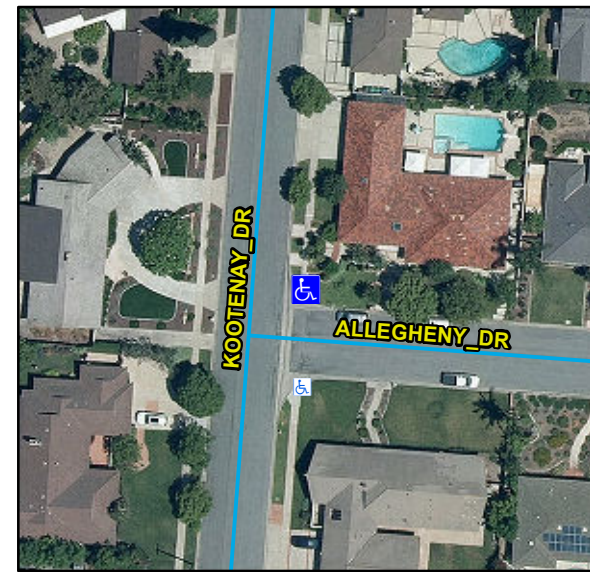
| Compliance | Description | Data | Compliance | Description | Data |
|---|---|---|---|---|---|
| No | Ramp Width (in) | 46 | | | N/A |
| No | Ramp Run Slope (%) | 8.5 | N/A | Flare Slope LT (%) | N/A |
| No | Ramp Cross Slope (%) | 3.5 | N/A | Flare Traversable LT | N/A |

Possible Solutions:

Remove & Replace Entire Ramp.

R304.5.1, R304.2.2, R304.5.3, STD 1115
