# Access Compliance Report Public Rights-of-Way (Curb Ramps)

Main Street: ALLEGHENY\_DR Cross Street: KOOTENAY\_DR Location: SE

ADA ID: RPAT211001102826 Ramp Type: Type 6 - Directional 1 Initial Pass/Fail: Fail Overall Compliance: No Severity Score: 5

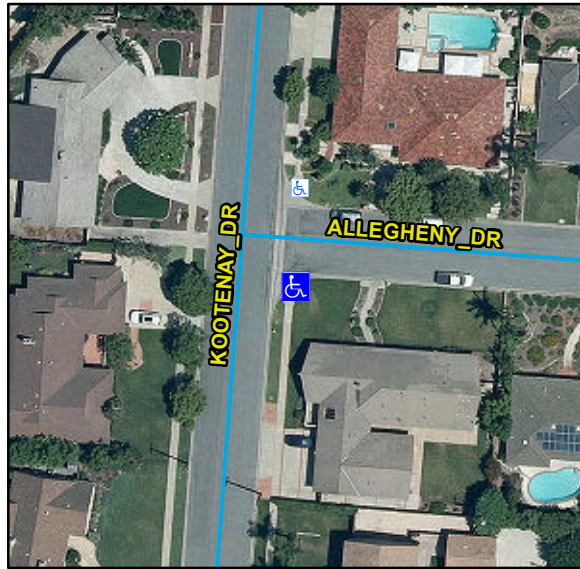
| Compliance | Description | Data | Compliance | Description | Data |
|---|---|---|---|---|---|
| No | Ramp Width (in) | 46 | | | N/A |
| No | Ramp Cross Slope (%) | 4.7 | N/A | Flare Traversable LT | N/A |

Remove & Replace Entire Ramp.

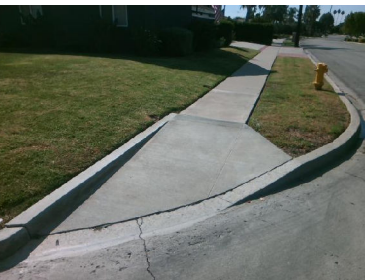
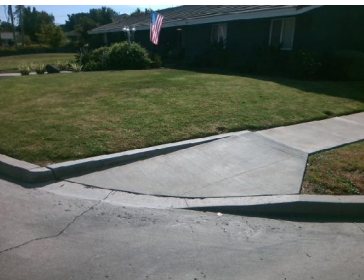
| Compliance | Description | Data | Compliance | Description | Data |
|---|---|---|---|---|---|
| Yes | Overall Surface Condition | Acceptable | Yes | Perp Joint Present | Yes |
