# Access Compliance Report Public Rights-of-Way (Curb Ramps)

| Main Street: KOOTENAY_DR | | Cross Street: CRANBROOK_DR | | Location: | SW |
| ADA ID: RPAT211001103354 | Ramp Type:Type 1 - Perpendicular Diagonal Initial Pass/Fail: Pass | | Overall Compliance: No | Severity Score: | 20 |

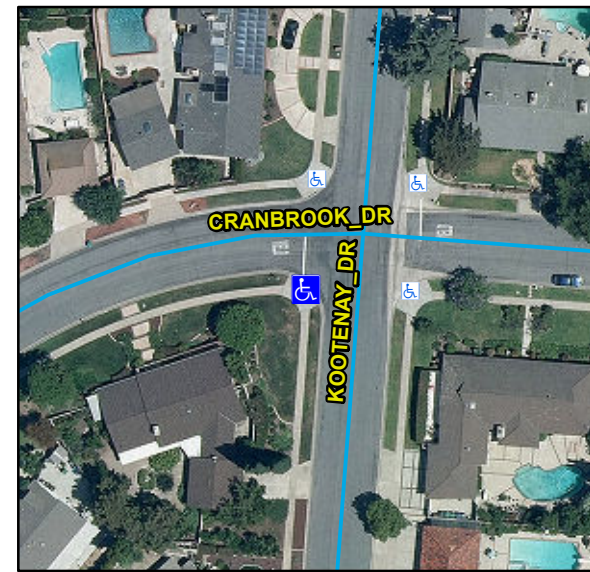
| Compliance | Description | Data | Compliance | Description | Data |
|---|---|---|---|---|---|
| No | Landing Width (in) | N/A | N/A | Flare Slope RT (%) | 4.8 |
| No | Landing Run Slope (%) | N/A | N/A | Flare Traversable RT | No |
| No | Landing Cross Slope (%) | N/A | No | DWS Provided | No |

Remove & Replace Curb Ramp With Two New Directional Ramps or Equivalent.

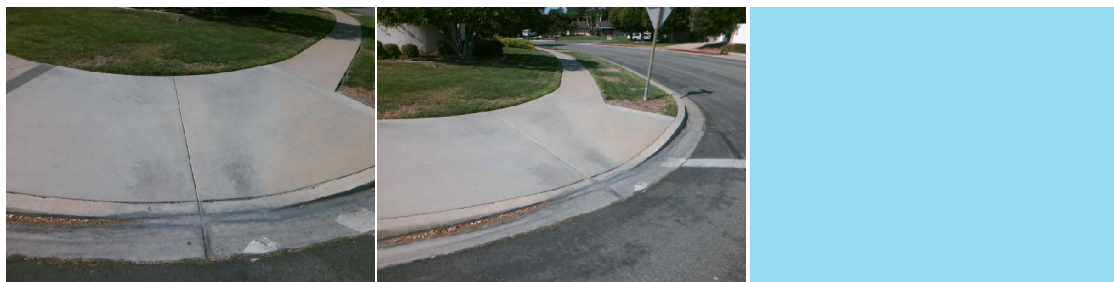
| Compliance | Description | Data | Compliance | Description | Data |
| N/A | Ramp Length (in) | 126 | N/A | Flare Type LT | |
| Yes | Ramp Width (in) | 48 | | | Sloped |
| Yes | Ramp Run Slope (%) | 7.6 | N/A | Flare Slope LT (%) | 5.6 |
