# Access Compliance Report Public Rights-of-Way (Curb Ramps)

Main Street: CRANBROOK\_DR Cross Street: KOOTENAY\_DR Location: NW

ADA ID: RPAT211001103815 Ramp Type: Type 1 - Perpendicular Diagonal Initial Pass/Fail: Pass Overall Compliance: No Severity Score: 20

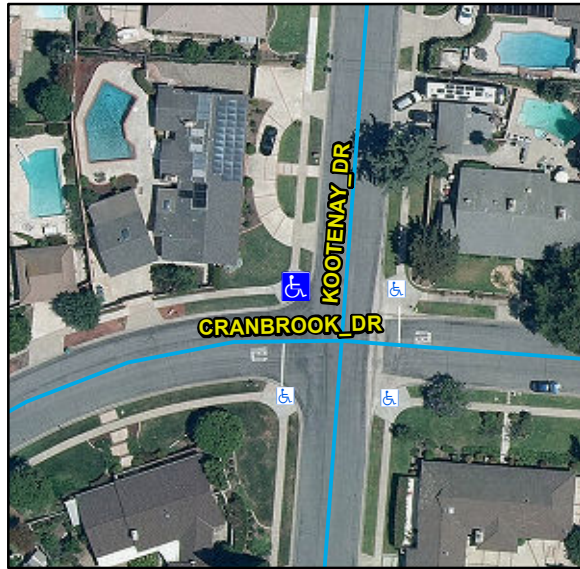
| Compliance | Description | Data | Compliance | Description | Data |
|---|---|---|---|---|---|
| N/A | Ramp Length (in) | 128 | N/A | Flare Type LT | |
| Yes | Ramp Width (in) | 57 | | | Sloped |
| Yes | Ramp Run Slope (%) | 6.7 | N/A | Flare Slope LT (%) | 5.2 |
| Yes | Ramp Cross Slope (%) | 1 | N/A | Flare Traversable LT | No |
| N/A | Landing Present | No | N/A | Flare Type RT | |
| No | Landing Width (in) | N/A | N/A | Flare Slope RT (%) | 8 |
| No | Landing Run Slope (%) | N/A | N/A | Flare Traversable RT | No |
| No | Landing Cross Slope (%) | N/A | No | DWS Provided | No |
| Yes | Gutter Ponding | No | No | Curb Slope | 8.9 |

Remove & Replace Curb Ramp With Two New Directional Ramps or Equivalent.

R304.2.2, R304.2.1, R304.2.2-Perp, R304.3.2-Para, R304.5.3, R305, STD 1115
