# Access Compliance Report Public Rights-of-Way (Curb Ramps)

Main Street: WHEELER\_PL Cross Street: WHITNEY\_DR Location: NE

ADA ID: RPAT211001112413 Ramp Type: Type 1 - Perpendicular Diagonal Initial Pass/Fail: Pass Overall Compliance: No Severity Score: 25

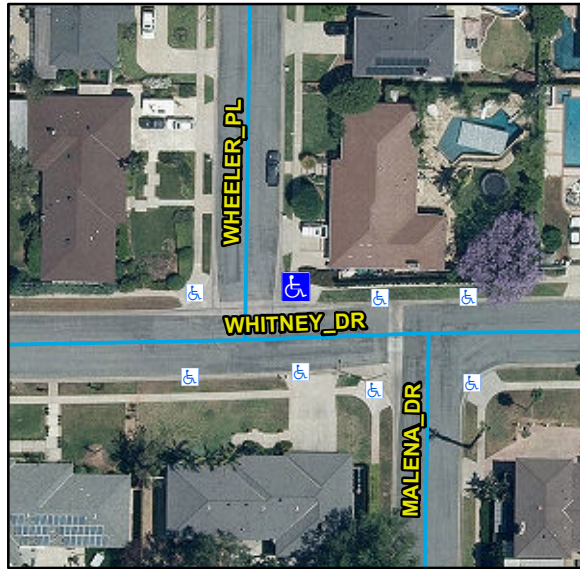
| Compliance | Description | Data | Compliance | Description | Data |
|---|---|---|---|---|---|
| No | Landing Width (in) | N/A | N/A | Flare Slope RT (%) | 4.6 |
| No | Landing Run Slope (%) | N/A | N/A | Flare Traversable RT | No |
| No | Landing Cross Slope (%) | N/A | No | DWS Provided | No |
| Yes | Gutter Ponding | No | No | Curb Slope | 10.8 |
| No | Gutter Run Slope (%) | 5.2 | | Road Cross Slope (%) | 7.5 |

Remove & Replace Curb Ramp With Two New Directional Ramps or Equivalent. Remove & Replace Gutter.
