# Access Compliance Report Public Rights-of-Way (Curb Ramps)

Main Street: WHITNEY\_DR Cross Street: MALENA\_DR Location: SE

ADA ID: RPAT211001113533 Ramp Type: Type 1 - Perpendicular Diagonal Initial Pass/Fail: Pass Overall Compliance: No Severity Score: 25

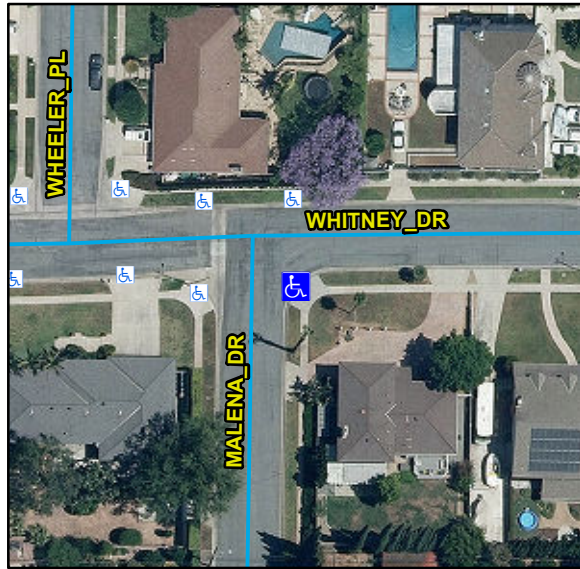
| Compliance | Description | Data | Compliance | Description | Data |
|---|---|---|---|---|---|
| Yes | Ramp Run Slope (%) | 7.9 | N/A | Flare Slope LT (%) | 8.2 |
| No | Landing Width (in) | N/A | N/A | Flare Slope RT (%) | 5.1 |
| No | Landing Run Slope (%) | N/A | N/A | Flare Traversable RT | No |
| No | Landing Cross Slope (%) | N/A | No | DWS Provided | No |
| Yes | Gutter Ponding | No | No | Curb Slope | 5.7 |
| No | Gutter Run Slope (%) | 6.5 | | Road Cross Slope (%) | 8 |

Remove & Replace Curb Ramp With Two New Directional Ramps or Equivalent. Remove & Replace Gutter.
