# Access Compliance Report Public Rights-of-Way (Curb Ramps)

Main Street: WHITNEY\_DR Cross Street: MALENA\_DR Location: NW

ADA ID: RPAT211001114358 Ramp Type: Type 1 - Perpendicular Diagonal Initial Pass/Fail: Fail Overall Compliance: No Severity Score: 16

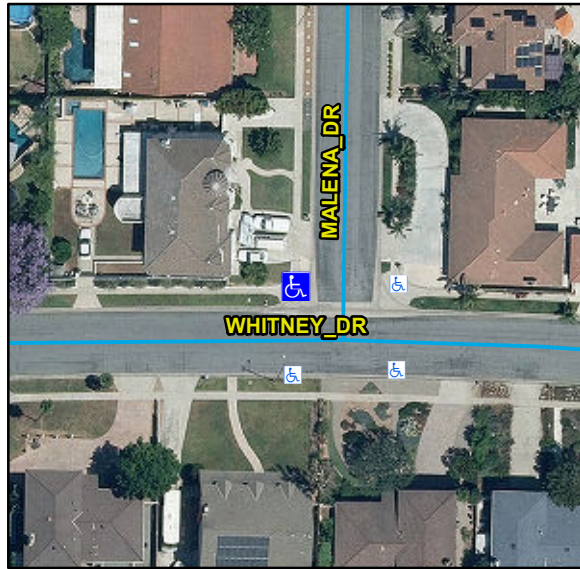
| Compliance | Description | Data | Compliance | Description | Data |
|---|---|---|---|---|---|
| No | Ramp Run Slope (%) | 8.7 | N/A | Flare Slope LT (%) | N/A |
| No | Ramp Cross Slope (%) | 2.9 | N/A | Flare Traversable LT | N/A |

**Remove & Replace Curb Ramp With Two New Directional Ramps or Equivalent.**

**R304.2.2, R304.5.3, STD 1115**
