# Access Compliance Report Public Rights-of-Way (Curb Ramps)

Main Street: MALENA\_DR Cross Street: WHITNEY\_DR Location: NE

ADA ID: RPAT211001115000 Ramp Type: Type 1 - Perpendicular Diagonal Initial Pass/Fail: Fail Overall Compliance: No Severity Score: 29

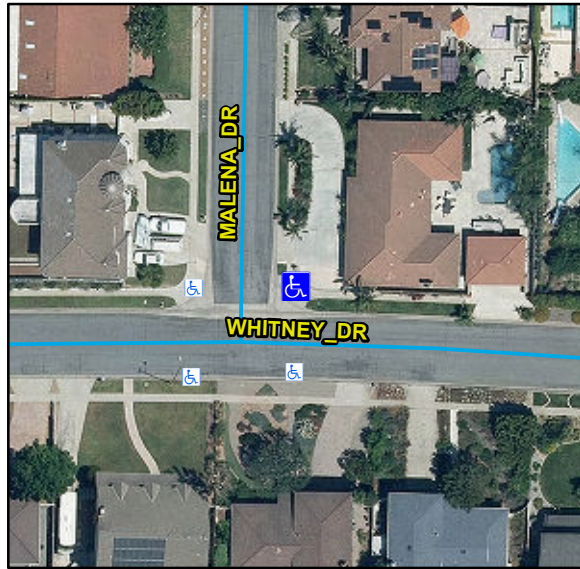
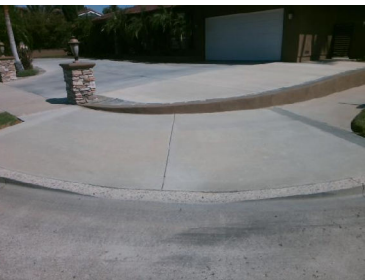
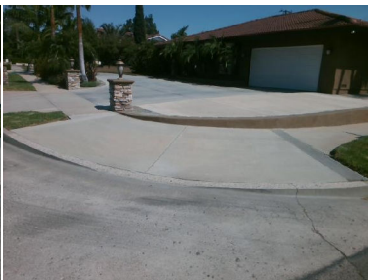
| Compliance | Description | Data | Compliance | Description | Data |
|---|---|---|---|---|---|
| No | Ramp Width (in) | 35 | | | N/A |
| No | Ramp Run Slope (%) | 9 | N/A | Flare Slope LT (%) | N/A |
| N/A | Gutter Ponding | N/A | No | Curb Slope | 10.4 |

**Remove & Replace Curb Ramp With Two New Directional Ramps or Equivalent.**

**R304.2.2, R304.5.1, STD 1115**
