# Access Compliance Report Public Rights-of-Way (Curb Ramps)

Main Street: LAURINDA\_WY Cross Street: WHITNEY\_DR Location: NE

ADA ID: RPAT211001120241 Ramp Type: Type 1 - Perpendicular Diagonal Initial Pass/Fail: Pass Overall Compliance: No Severity Score: 22

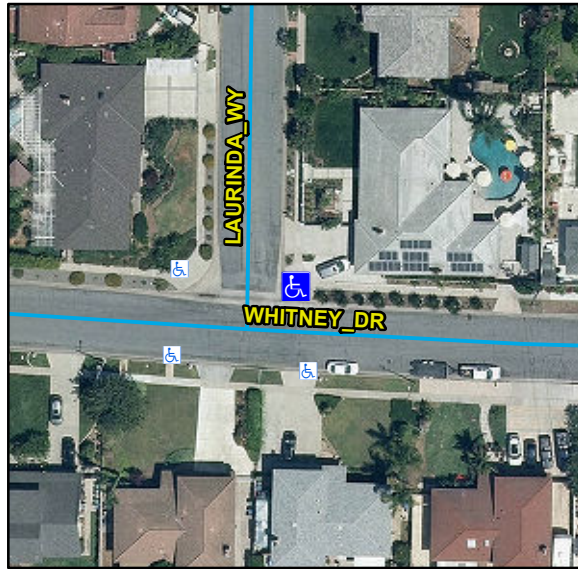
R304.2.2, R204.3, R304.2.1, R304.2.2-Perp, R304.3.2-Para, R304.5.3, R305, STD 1115

| Compliance | Description | Data | Compliance | Description | Data |
|---|---|---|---|---|---|
| No | Landing Width (in) | N/A | N/A | Flare Slope RT (%) | 7.4 |
| No | Landing Run Slope (%) | N/A | N/A | Flare Traversable RT | No |
| No | Landing Cross Slope (%) | N/A | No | DWS Provided | No |
| Yes | Gutter Ponding | No | No | Curb Slope | 8.4 |

Remove & Replace Curb Ramp With Two New Directional Ramps or Equivalent.

Total Cost: \$ 6160
