# Access Compliance Report Public Rights-of-Way (Curb Ramps)

Main Street: WHITNEY\_DR Cross Street: LAURINDA\_WY Location: NW

ADA ID: RPAT211001120542 Ramp Type: Type 1 - Perpendicular Diagonal Initial Pass/Fail: Pass Overall Compliance: No Severity Score: 22

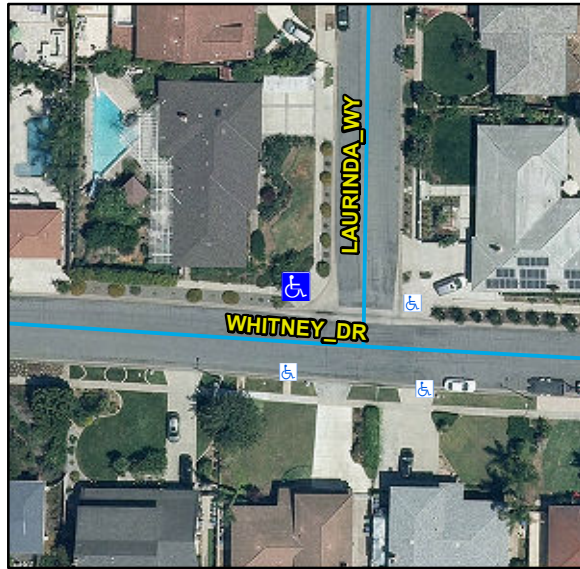
| Compliance | Description | Data | Compliance | Description | Data |
|---|---|---|---|---|---|
| Yes | Ramp Run Slope (%) | 7 | N/A | Flare Slope LT (%) | 6.2 |
| Yes | Ramp Cross Slope (%) | 0.8 | N/A | Flare Traversable LT | No |
| No | Landing Width (in) | N/A | N/A | Flare Slope RT (%) | 8.5 |
| No | Landing Run Slope (%) | N/A | N/A | Flare Traversable RT | No |
| No | Landing Cross Slope (%) | N/A | No | DWS Provided | No |
| Yes | Gutter Ponding | No | No | Curb Slope | 6.5 |

Remove & Replace Curb Ramp With Two New Directional Ramps or Equivalent.
