# Access Compliance Report Public Rights-of-Way (Curb Ramps)

Main Street: WESTON\_PL Cross Street: LIVINGSTON\_AVE Location: NW

ADA ID: RPAT211001140555 Ramp Type: Type 1 - Perpendicular Diagonal Initial Pass/Fail: Fail Overall Compliance: No Severity Score: 15

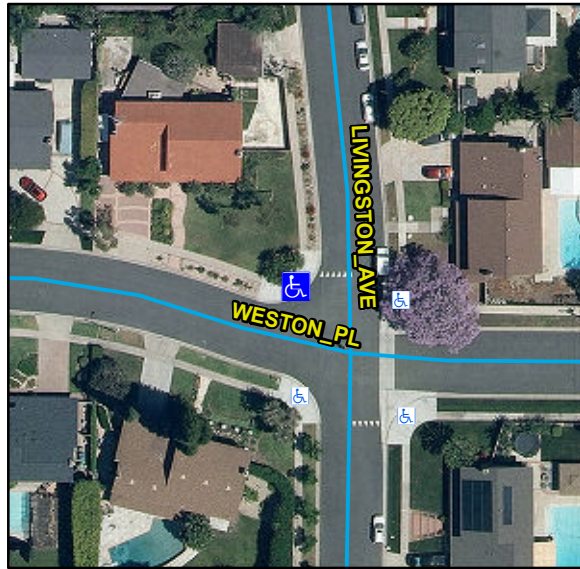
| Compliance | Description | Data | Compliance | Description | Data |
|---|---|---|---|---|---|
| No | Ramp Run Slope (%) | 8.9 | N/A | Flare Slope LT (%) | N/A |

**Remove & Replace Curb Ramp With Two New Directional Ramps or Equivalent.**

**R304.2.2, STD 1115**

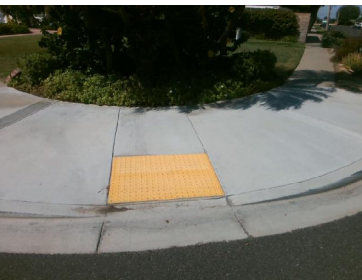
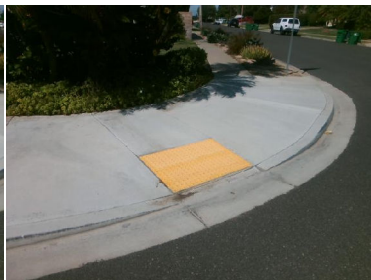
| Compliance | Description | Data | Compliance | Description | Data |
|---|---|---|---|---|---|
| Yes | Overall Surface Condition: <b>Acceptable</b> | | Yes | Perp Joint Present | Yes |
