# Access Compliance Report Public Rights-of-Way (Curb Ramps)

Main Street: WESTON\_PL Cross Street: LIVINGSTON\_AVE Location: SE

ADA ID: RPAT211001141207 Ramp Type: Type 1 - Perpendicular Diagonal Initial Pass/Fail: Pass Overall Compliance: No Severity Score: 0

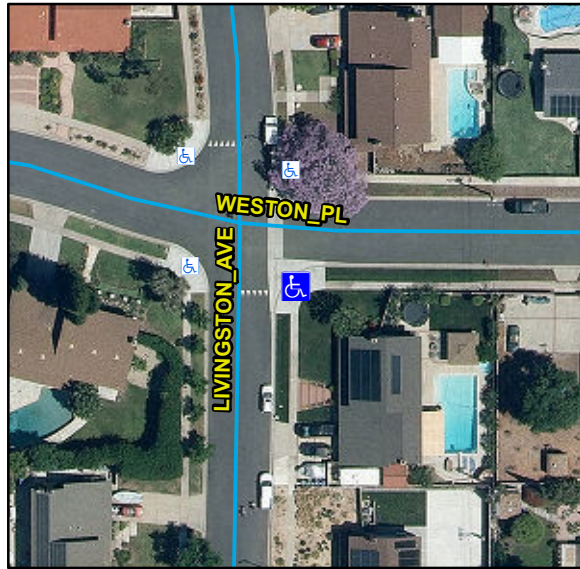
| Compliance | Description | Data | Compliance | Description | Data |
|---|---|---|---|---|---|
| Yes | Gutter Ponding | No | No | Curb Slope | 6.8 |
| No | Gutter Cross Slope (%) | 2.4 | | | |

Remove & Replace Curb Slope. Remove & Replace Gutter.
