# Access Compliance Report Public Rights-of-Way (Curb Ramps)

Main Street: MATRYCE\_WAY Cross Street: WESTON\_PL Location: NE

ADA ID: RPAT211001141816 Ramp Type: Type 1 - Perpendicular Diagonal Initial Pass/Fail: Pass Overall Compliance: No Severity Score: 0

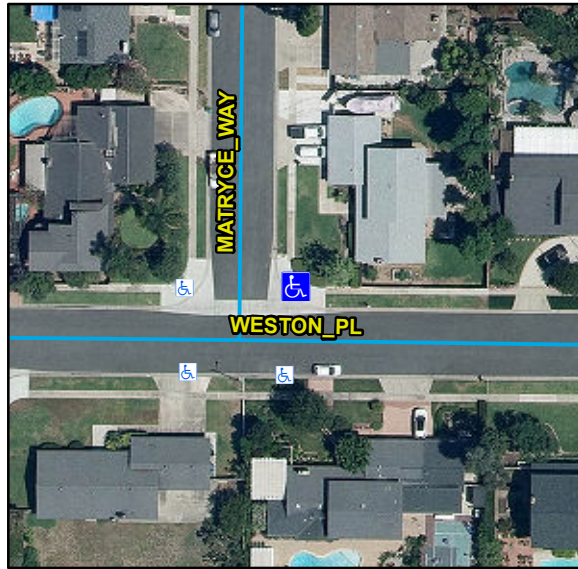
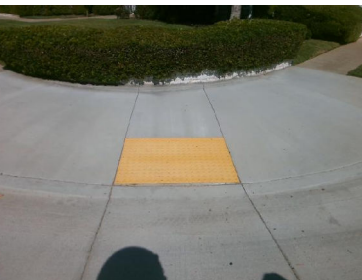
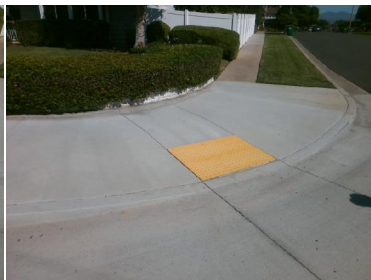
| Compliance | Description | Data | Compliance | Description | Data |
|---|---|---|---|---|---|
| N/A | Landing Movement Obstructed? | Yes | Yes | DWS Contrast | Yes |
| | Landing Movement Type | Curb | Yes | DWS Length (in) | 36 |

Remove & Replace Landing.

R304.2.1, STD 1115
