# Access Compliance Report Public Rights-of-Way (Curb Ramps)

Main Street: WESTON\_PL Cross Street: MATRYCE\_WAY Location: NW

ADA ID: RPAT211001142337 Ramp Type: Type 1 - Perpendicular Diagonal Initial Pass/Fail: Pass Overall Compliance: No Severity Score: 0

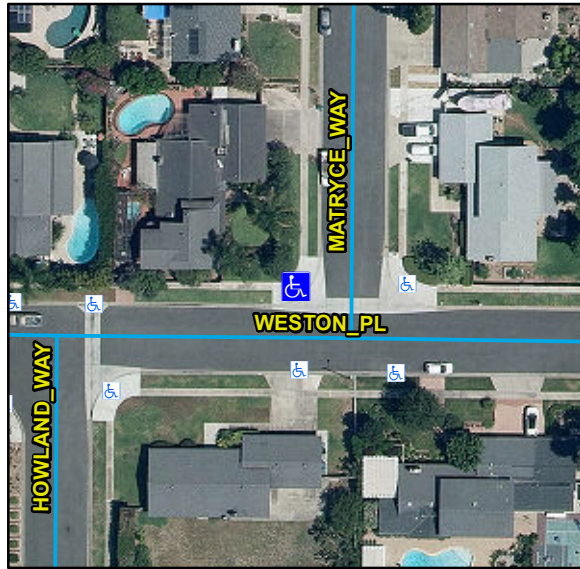
| Compliance | Description | Data | Compliance | Description | Data |
|---|---|---|---|---|---|
| Yes | Gutter Ponding | No | No | Curb Slope | 9 |
| No | Gutter Cross Slope (%) | 2.4 | | | |

Remove & Replace Curb Slope. Remove & Replace Gutter.

R304.2.2, R304.5.3, STD 1115
