# Access Compliance Report Public Rights-of-Way (Curb Ramps)

Main Street: HOWLAND\_WAY Cross Street: WESTON\_PL Location: SW

ADA ID: RPAT211001143219 Ramp Type: Type 1 - Perpendicular Diagonal Initial Pass/Fail: Pass Overall Compliance: No Severity Score: 7

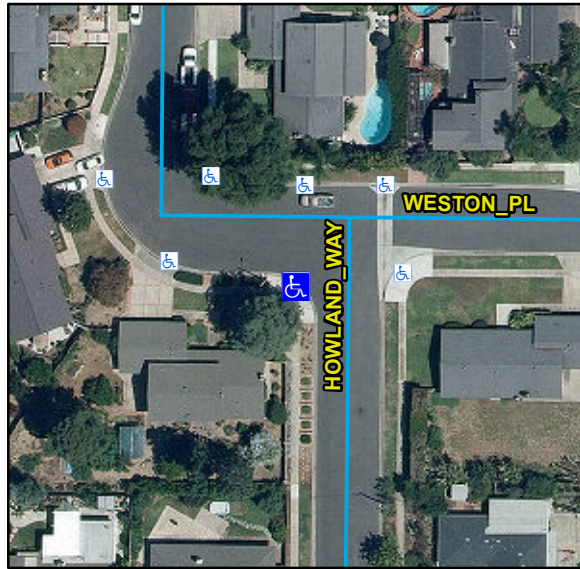
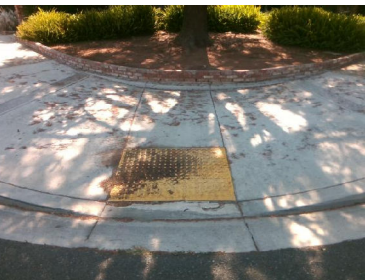
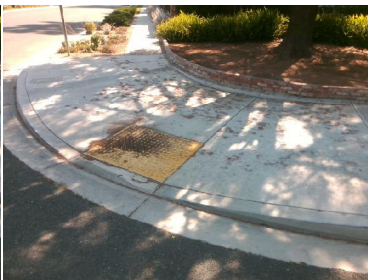
| Compliance | Description | Data | Compliance | Description | Data |
|---|---|---|---|---|---|
| No | Landing Cross Slope (%) | 2.7 | Yes | DWS Provided | Yes |
| Yes | Gutter Ponding | No | No | Curb Slope | 6.8 |
| No | Gutter Run Slope (%) | 7 | | Road Cross Slope (%) | 6.9 |

Remove & Replace Curb Ramp With Two New Directional Ramps or Equivalent. Remove & Replace Gutter.

R304.2.2, R304.5.3, R304.5.4, STD 1115
