# Access Compliance Report Public Rights-of-Way (Curb Ramps)

Main Street: BENETA\_WAY Cross Street: LIVINGSTON\_ST Location: SE

ADA ID: RPAT211004085603 Ramp Type: Type 1 - Perpendicular Diagonal Initial Pass/Fail: Fail Overall Compliance: No Severity Score: 2

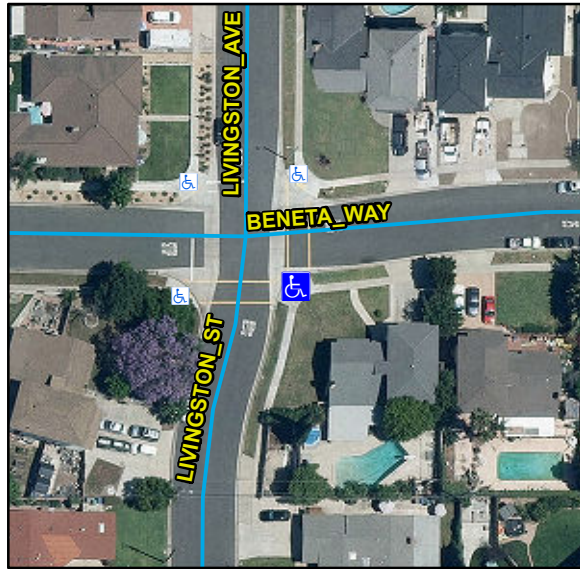
| Compliance | Description | Data | Compliance | Description | Data |
|---|---|---|---|---|---|
| No | Ramp Cross Slope (%) | 2.5 | N/A | Flare Traversable LT | N/A |
| N/A | Gutter Ponding | N/A | No | Curb Slope | 12.2 |

Remove & Replace Curb Ramp With Two New Directional Ramps or Equivalent.

R304.2.2, R304.5.3, STD 1115
