# Access Compliance Report Public Rights-of-Way (Curb Ramps)

Main Street: LIVINGSTON\_AVE Cross Street: BENETA\_WAY Location: NE

ADA ID: RPAT211004085841 Ramp Type: Type 1 - Perpendicular Diagonal Initial Pass/Fail: Pass Overall Compliance: No Severity Score: 0

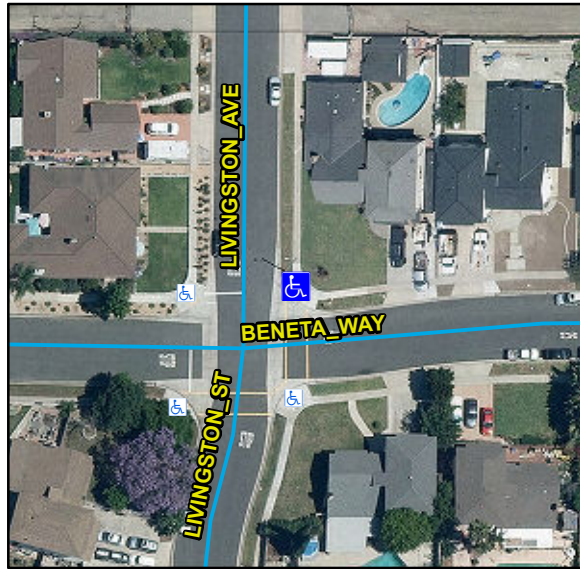
| Compliance | Description | Data | Compliance | Description | Data |
|---|---|---|---|---|---|
| Yes | Gutter Ponding | No | No | Curb Slope | 7.2 |

Remove & Replace Curb Slope.

R304.2.2, STD 1115

Total Cost: \$ 252
