# Access Compliance Report Public Rights-of-Way (Curb Ramps)

Main Street: LIVINGSTON\_AVE Cross Street: LUCERO\_WAY Location: NE

ADA ID: RPAT211004090808 Ramp Type: Type 1 - Perpendicular Diagonal Initial Pass/Fail: Pass Overall Compliance: No Severity Score: 2

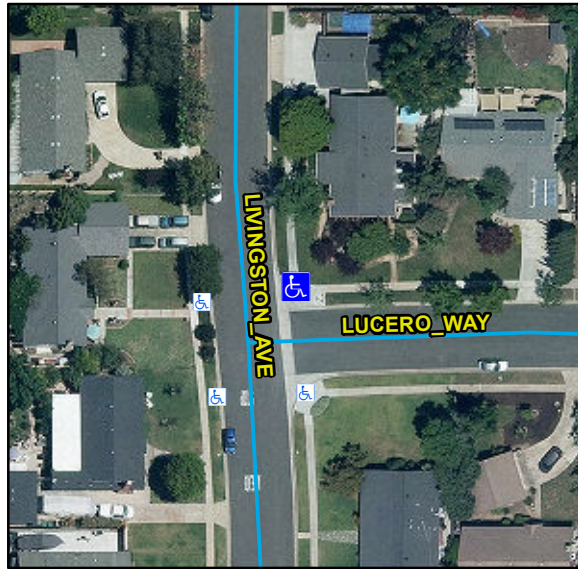
| Compliance | Description | Data | Compliance | Description | Data |
|---|---|---|---|---|---|
| Yes | Gutter Ponding | No | No | Curb Slope | 7.9 |

Remove & Replace Curb Slope.

R304.2.2, STD 1115
