# Access Compliance Report Public Rights-of-Way (Curb Ramps)

Main Street: KIRK\_AVE Cross Street: LIVINGSTON\_AVE Location: SE

ADA ID: RPAT211004093336 Ramp Type: Type 1 - Perpendicular Diagonal Initial Pass/Fail: Fail Overall Compliance: No Severity Score: 2

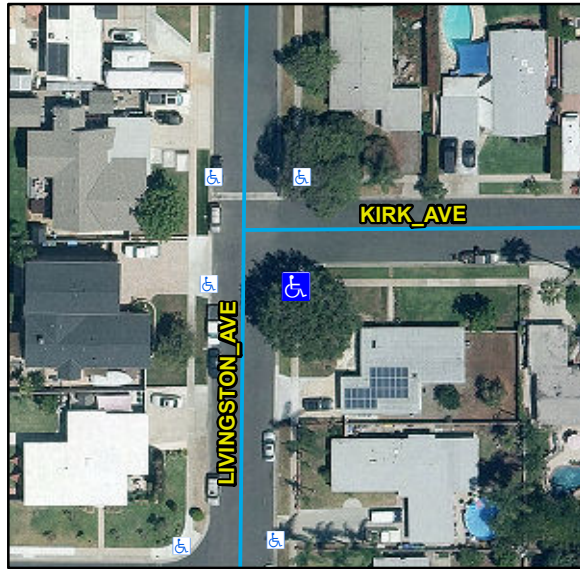
| Compliance | Description | Data | Compliance | Description | Data |
|---|---|---|---|---|---|
| No | Ramp Cross Slope (%) | 2.1 | N/A | Flare Traversable LT | N/A |

Remove & Replace Curb Ramp With Two New Directional Ramps or Equivalent.
