# Access Compliance Report Public Rights-of-Way (Curb Ramps)

Main Street: BENETA\_WAY Cross Street: LIVINGSTON\_AVE Location: NE

ADA ID: RPAT211004095922 Ramp Type: Type 1 - Perpendicular Diagonal Initial Pass/Fail: Pass Overall Compliance: No Severity Score: 0

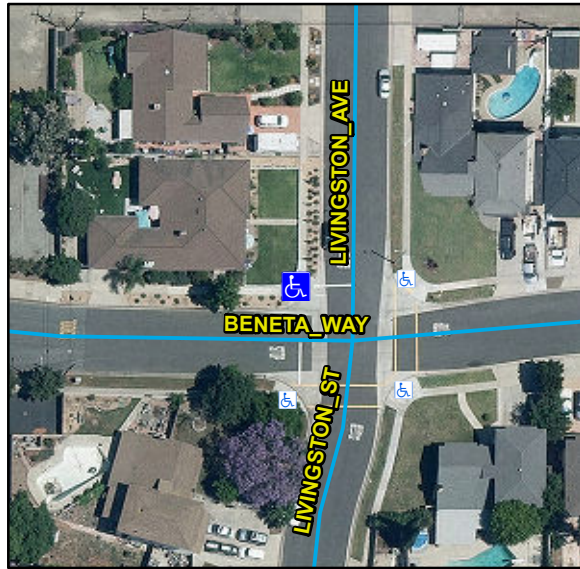
| Compliance | Description | Data | Compliance | Description | Data |
|---|---|---|---|---|---|
| No | Landing Run Slope (%) | 2.2 | N/A | Flare Traversable RT | No |
| Yes | Gutter Ponding | No | No | Curb Slope | 5.9 |

Remove & Replace Curb Ramp With Two New Directional Ramps or Equivalent.

R304.2.2, R304.2.2-Perp, R304.3.2-Para, STD 1115
