# Access Compliance Report Public Rights-of-Way (Curb Ramps)

Main Street: LIVINGSTON\_ST Cross Street: BENETA\_WAY Location: SW

ADA ID: RPAT211004100646 Ramp Type: Type 1 - Perpendicular Diagonal Initial Pass/Fail: Fail Overall Compliance: No Severity Score: 2

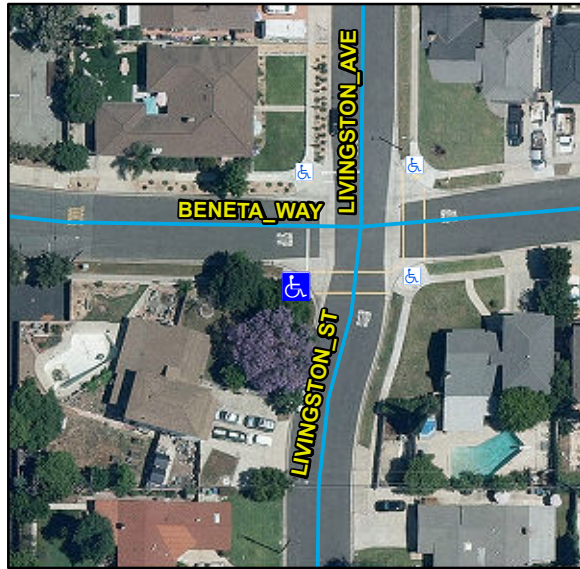
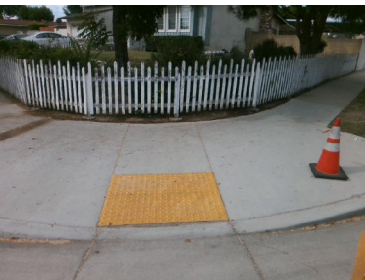
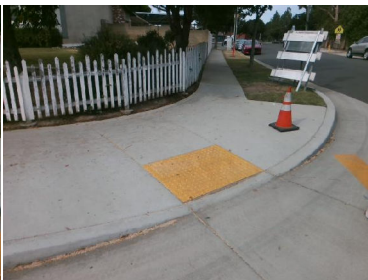
| Compliance | Description | Data | Compliance | Description | Data |
|---|---|---|---|---|---|
| No | Ramp Cross Slope (%) | 3.2 | N/A | Flare Traversable LT | N/A |

Remove & Replace Curb Ramp With Two New Directional Ramps or Equivalent.

R304.2.2, R304.5.3, STD 1115
