# Access Compliance Report Public Rights-of-Way (Curb Ramps)

Main Street: WELLINGTON\_AVE Cross Street: SHASTA\_WAY Location: NW

ADA ID: RPAT211004103820 Ramp Type: Type 6 - Directional 1 Initial Pass/Fail: Fail Overall Compliance: No Severity Score: 4

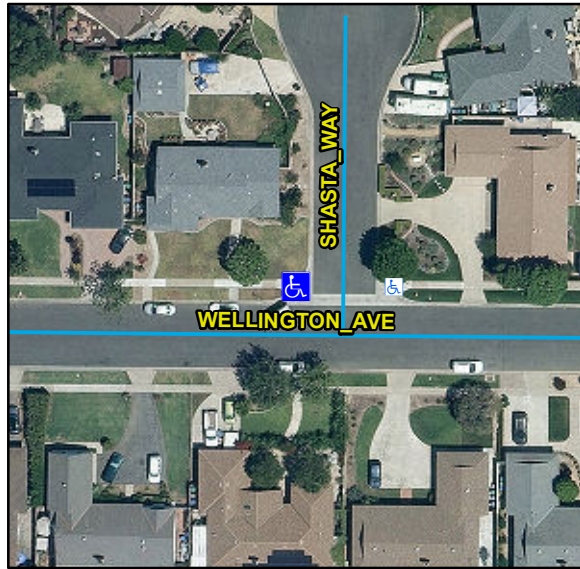
| Compliance | Description | Data | Compliance | Description | Data |
|---|---|---|---|---|---|
| No | Ramp Width (in) | 47 | | | N/A |

**Remove & Replace Curb Ramp With Two New Directional Ramps or Equivalent.**

**R304.5.1, STD 1115**
