# Access Compliance Report Public Rights-of-Way (Curb Ramps)

Main Street: SHASTA\_WAY Cross Street: WELLINGTON\_AVE Location: NE

ADA ID: RPAT211004104240 Ramp Type: Type 6 - Directional 1 Initial Pass/Fail: Fail Overall Compliance: No Severity Score: 5

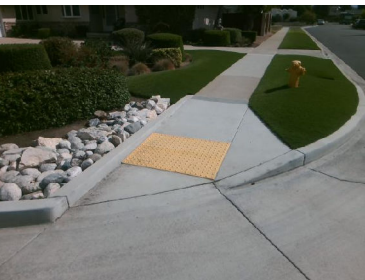
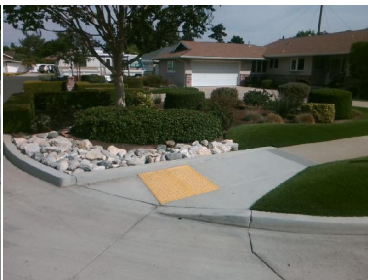
| Compliance | Description | Data | Compliance | Description | Data |
|---|---|---|---|---|---|
| No | Ramp Width (in) | 47 | | | N/A |

**Remove & Replace Curb Ramp With Two New Directional Ramps or Equivalent.**

**R304.5.1, STD 1115**
