# Access Compliance Report Public Rights-of-Way (Curb Ramps)

Main Street: N/A Cross Street: HOLT\_AVE Location: SE

ADA ID: RPAT211004132915 Ramp Type: Type 1 - Perpendicular Initial Pass/Fail: Pass Overall Compliance: No Severity Score: 4

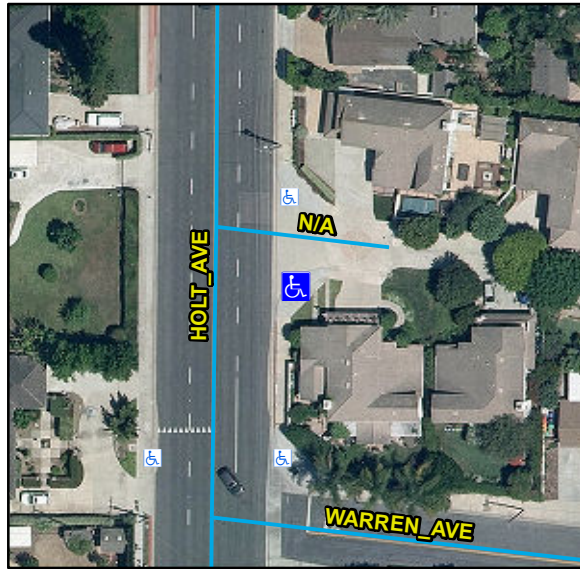
| Compliance | Description | Data | Compliance | Description | Data |
|---|---|---|---|---|---|
| No | Landing Run Slope (%) | 2.9 | N/A | Flare Traversable RT | Yes |

Remove & Replace Landing.
