# Access Compliance Report Public Rights-of-Way (Curb Ramps)

Main Street: N/A Cross Street: HOLT\_AVE Location: NE

ADA ID: RPAT211004133206 Ramp Type: Type 1 - Perpendicular Initial Pass/Fail: Fail Overall Compliance: No Severity Score: 4

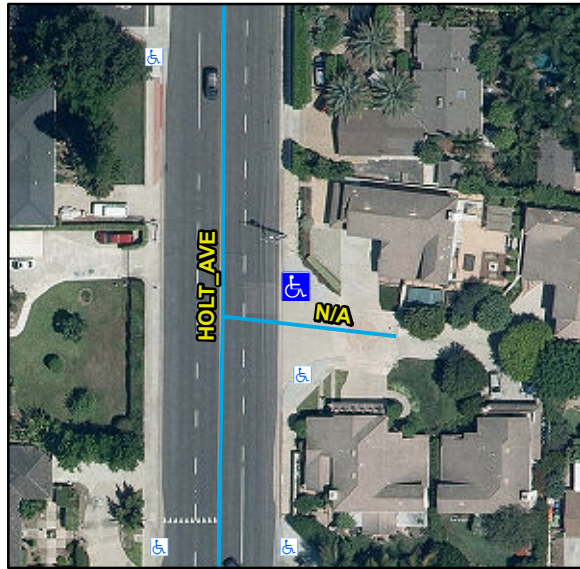
| Compliance | Description | Data | Compliance | Description | Data |
|---|---|---|---|---|---|
| No | Ramp Width (in) | 47 | | | N/A |

Remove & Replace Entire Ramp.
