# Access Compliance Report Public Rights-of-Way (Curb Ramps)

Main Street: NORWOOD\_PKWY Cross Street: HOLT\_AVE Location: SW

ADA ID: RPAT211004133453 Ramp Type: Type 7 - Directional 2 Initial Pass/Fail: Fail Overall Compliance: No Severity Score: 2

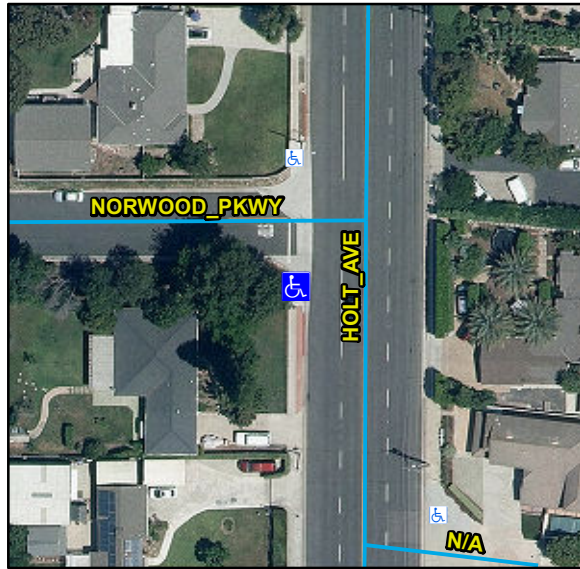
| Compliance | Description | Data | Compliance | Description | Data |
|---|---|---|---|---|---|
| No | Ramp Cross Slope (%) | 2.2 | N/A | Flare Traversable LT | N/A |

Remove & Replace Entire Ramp. Replace Spandrel.

R304.5.3, STD 122-2, STD 1115
